**Air Branch Inspection Report  
Unannounced Partial Compliance Evaluation  
SA Recycling LLC (PSC Metals)**

3620 N. Hall Street  
St. Louis, MO 63147  
FRS# 110001452918

**Inspection Date(s):**  
June 7, 2022

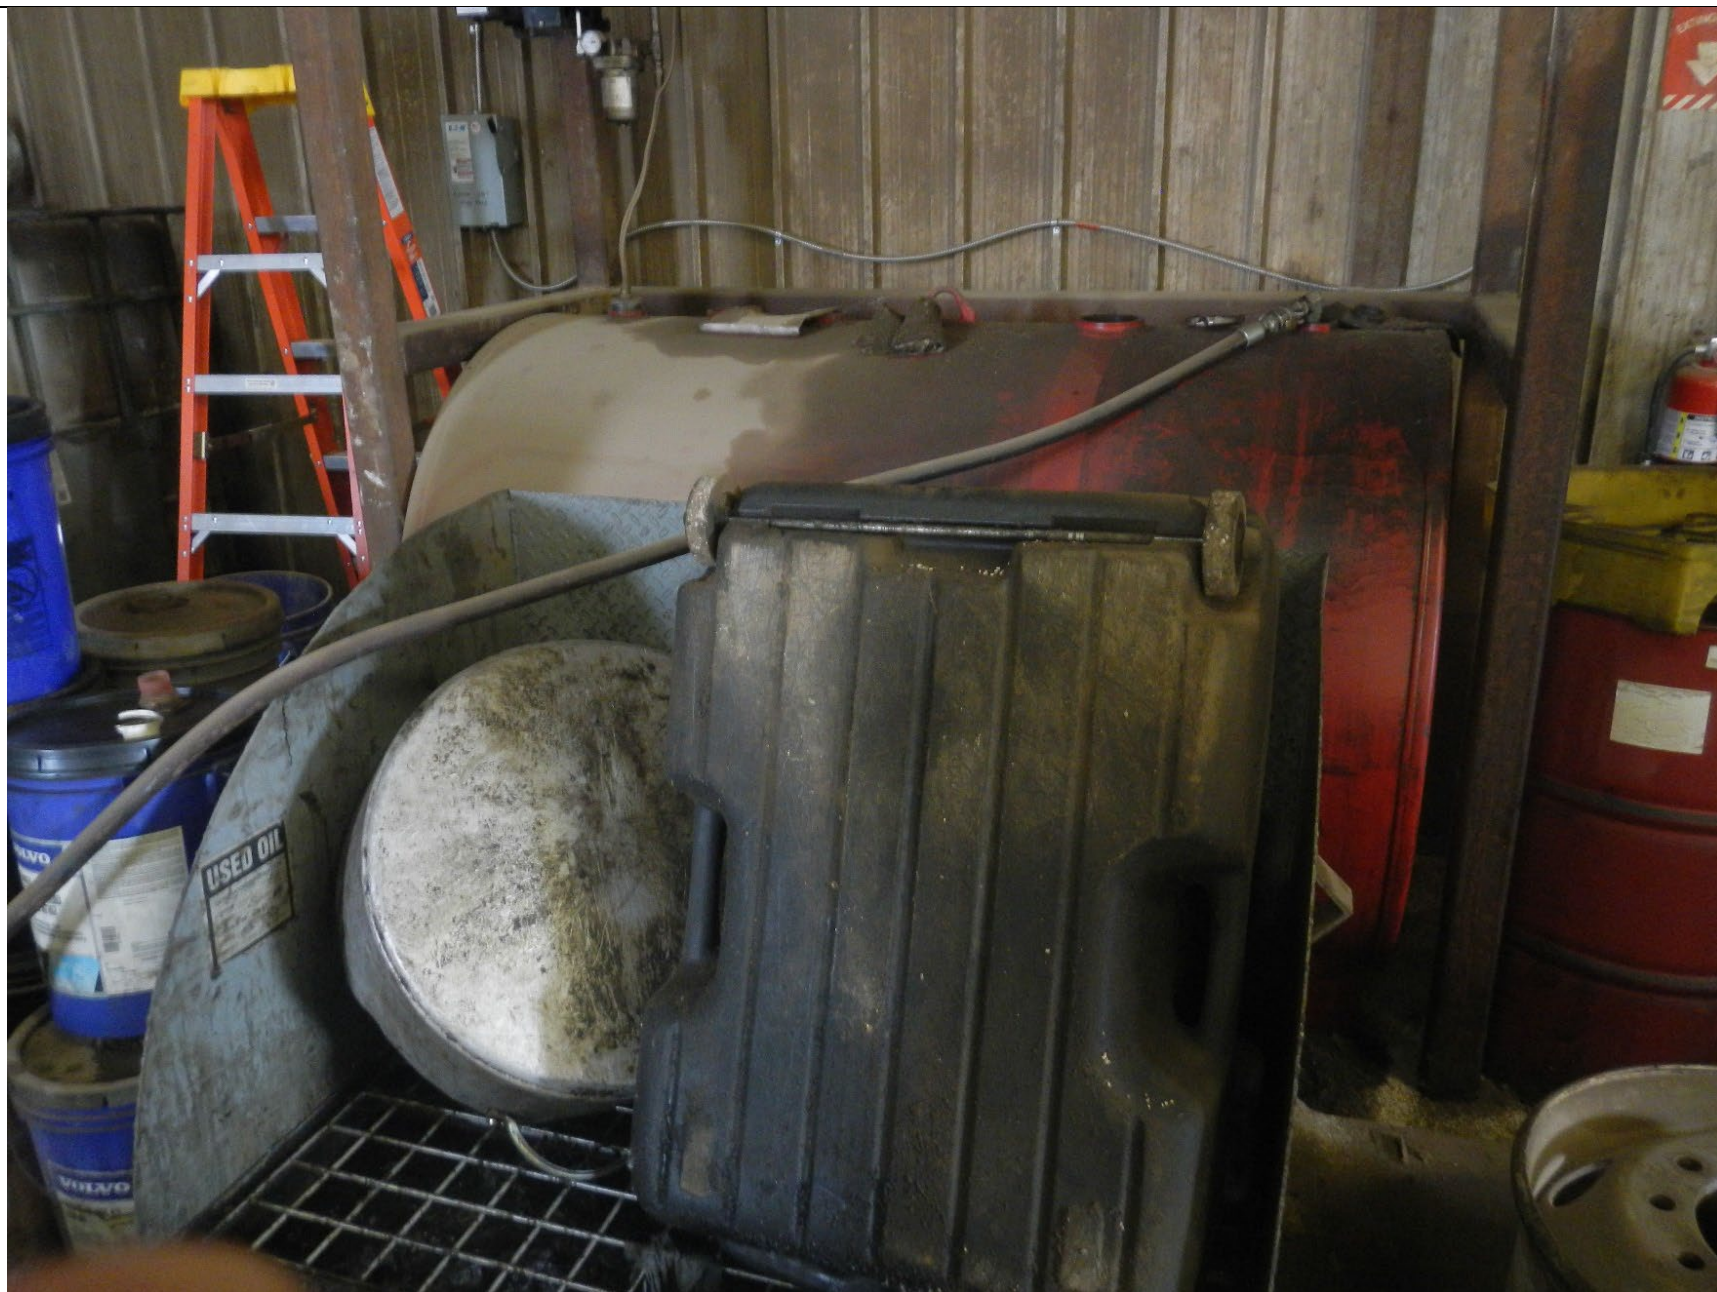
There is a CB-3500 waste oil furnace with a heating capacity of 0.35 MMBtu per hour and 2.3 gallons per hour located in the machine shop. This operation is specifically authorized under 40 CFR 279.23. I estimated emissions from the unit using AP42 Chapter 1.11 Waste Oil Combustion emission factors for space heaters. Emissions from this unit are likely below regulatory de minimis levels located in 10 CSR 10-6.020. There is no other stationary combustion equipment on-site.

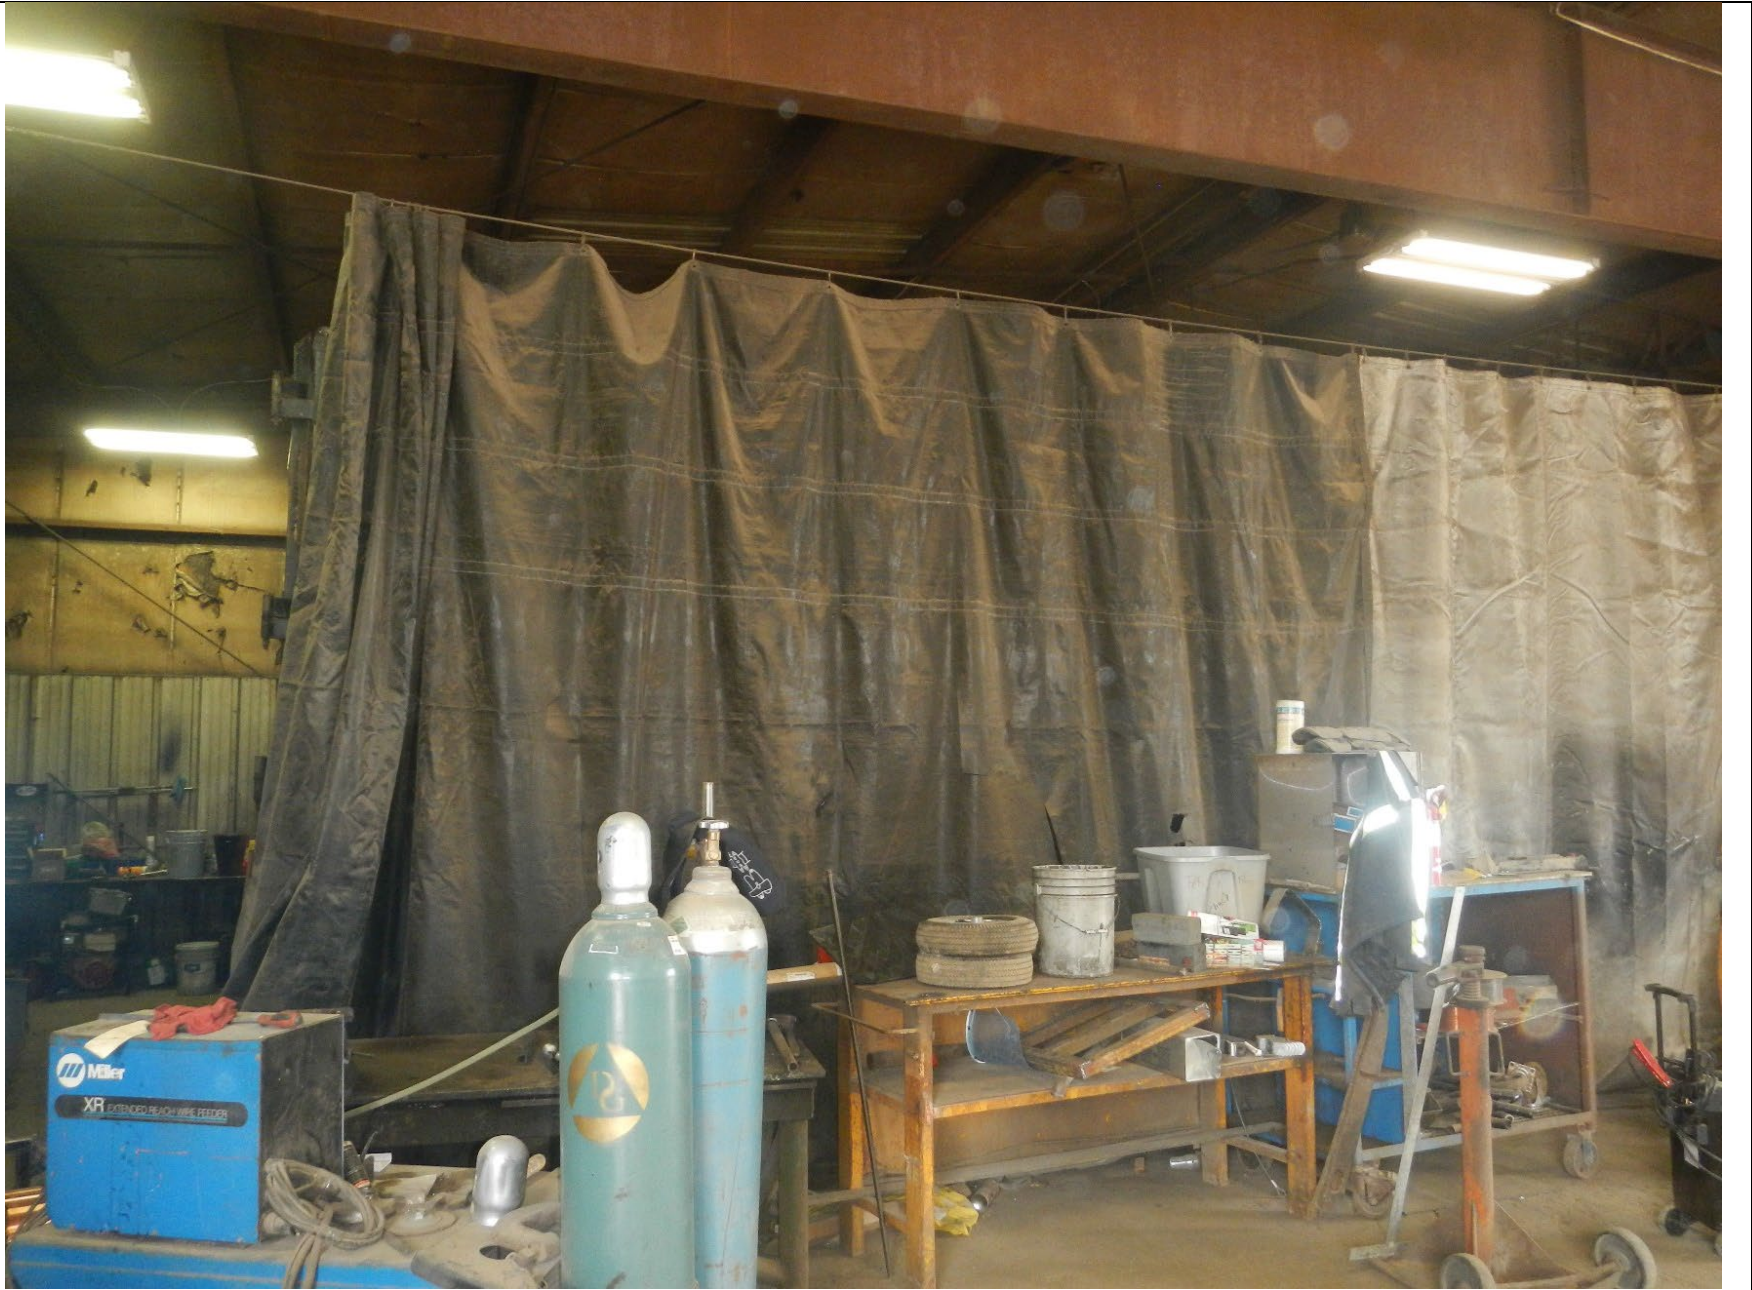
The facility also paints in the maintenance shop. The spray enclosure can be seen in Photos 3 and 4 and the sprayer used can be seen in Photo 5 of **Appendix A**. The SDS for the paint used in this application is attached as **Appendix D**. This paint contains VOCs. The paint enclosure and operation should be evaluated with the designated permitting authority. The painting operation may also be subject to 40 CFR 63 Subpart HHHHHH. The state of Missouri is not delegated authority for 40 CFR 63 Subpart HHHHHH and therefore EPA is the delegated authority for implementing and enforcing this rule.

<b>Potential Finding 2:</b> Facility possibly Subject to 40 CFR 63 Subject HHHHHH
<b>Observation Summary:</b> Painting operation at the facility
<b>Citation:</b> 40 CFR 63 Subpart HHHHHH
<b>Evidence:</b> Photos 3, 4 and 5 in Appendix A.
<b>Description of Observation:</b> I observed a painting enclosure and a paint sprayer in the maintenance shop.
